# **Coal Burner Condition and Estimated Remaining Life Evaluation - Intermountain Generating Station**

## **Final Report**

**Intermountain Power Service Corporation**

August 15, 1990

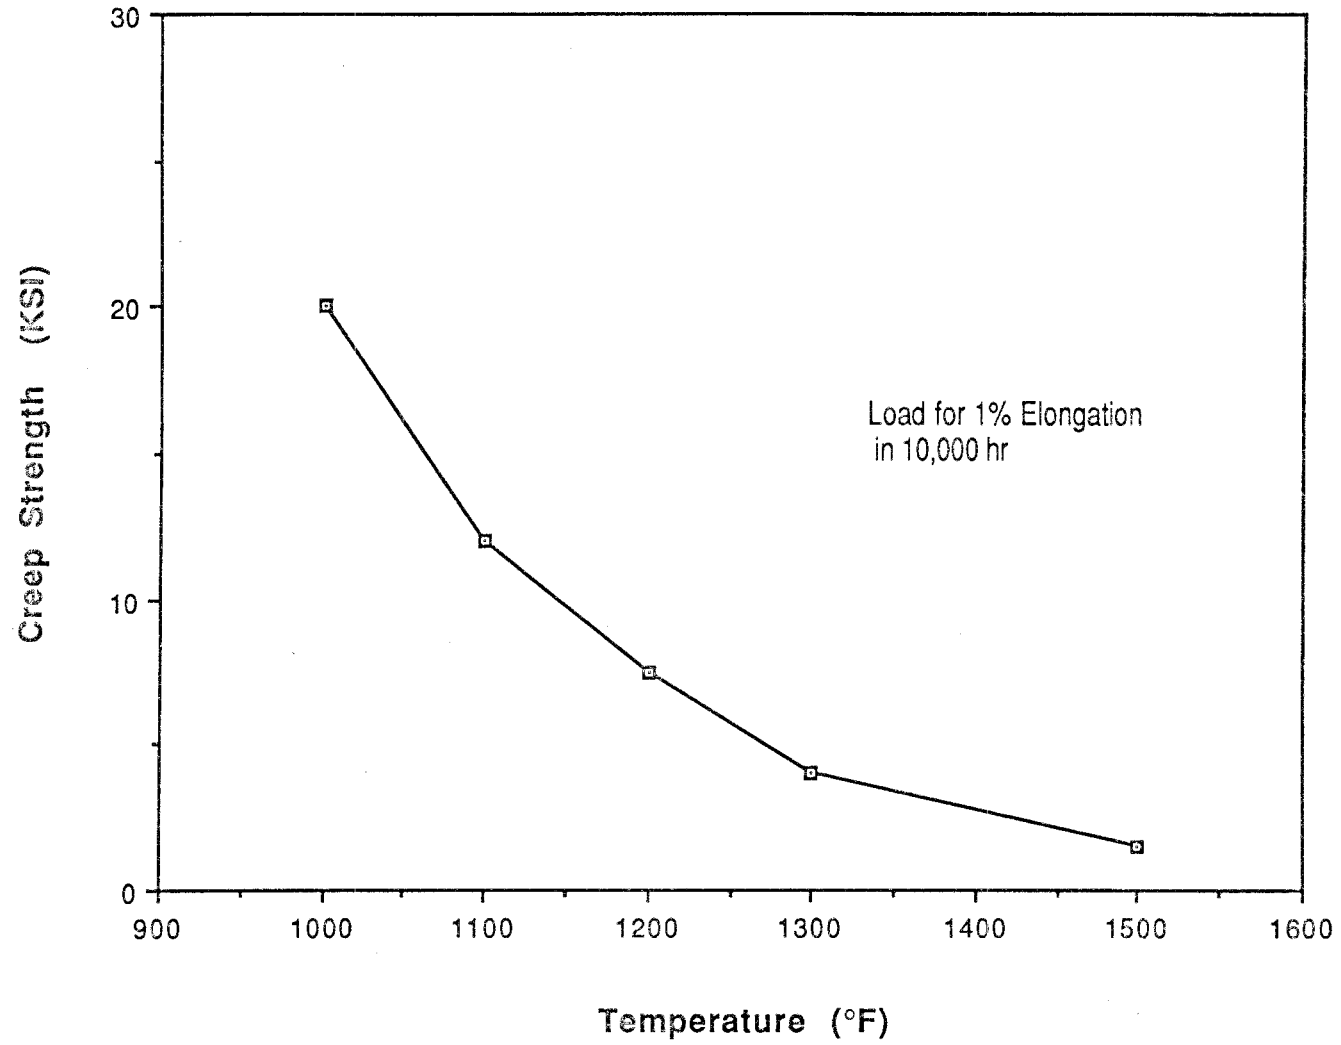
temperature under stress. Depending on the information source, the creep strength of AISI 304 stainless steel is reported as approximately 9.5 KSI at 1150°F and 3 KSI at 1350°F. Figure 3 illustrates the creep strength vs. temperature relationship for 304 stainless steel. For a long term installation such as this burner, the 304 stainless material should be limited to 1150°F.

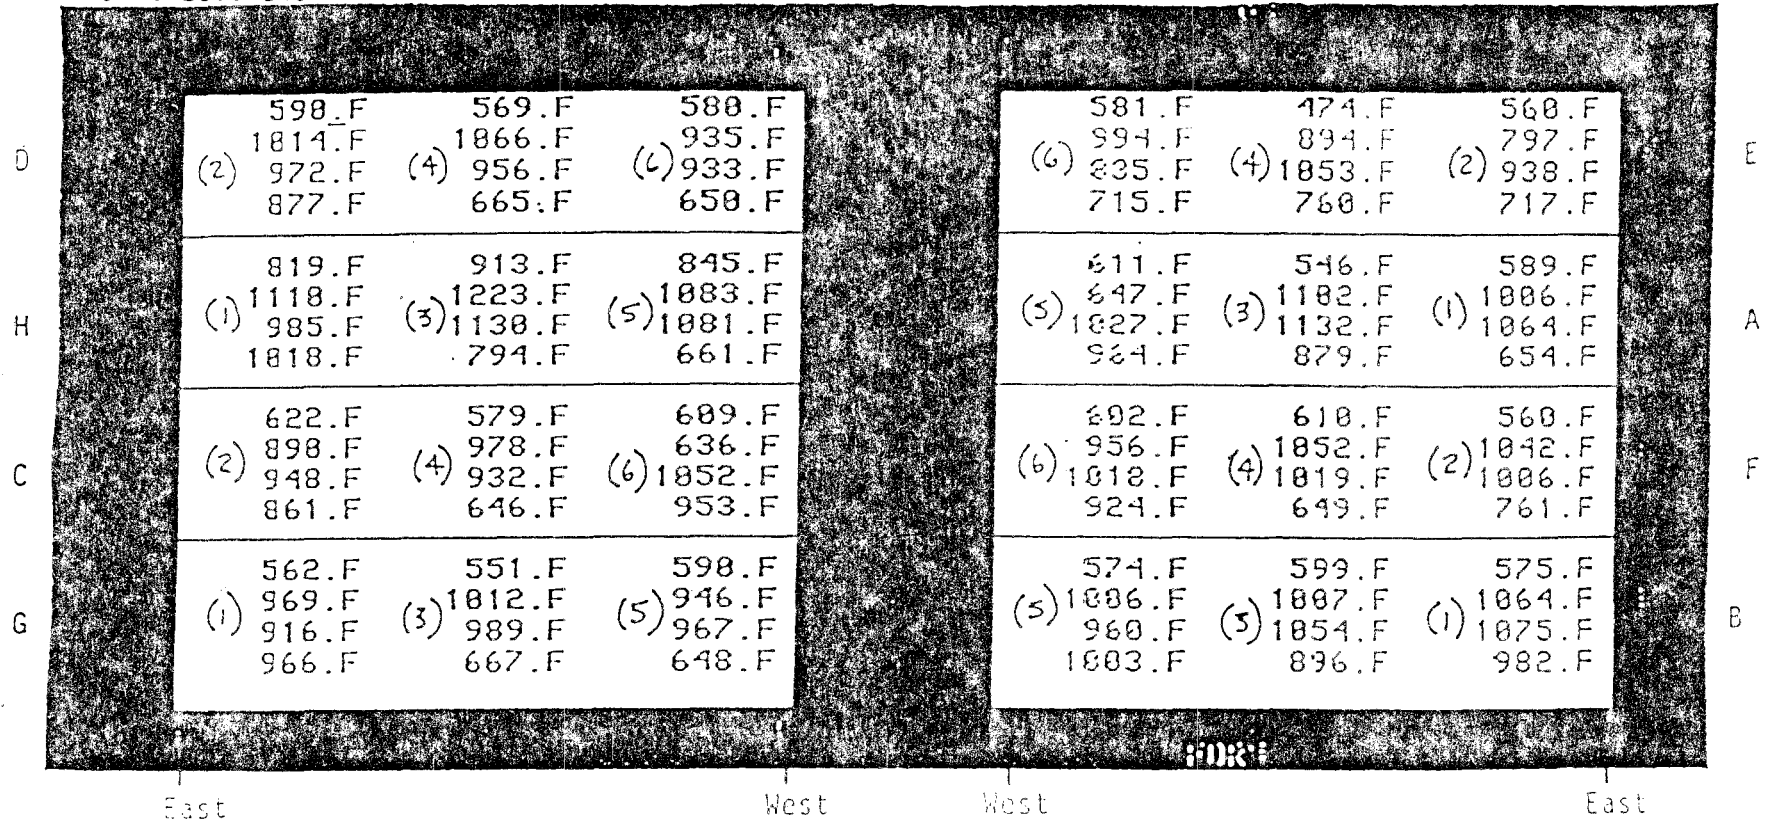
TYPICAL BURNER THERMOCOUPLE INDICATIONS  
Figure 4

It was apparent from the inspection that temperature variations around the burner exist during boiler operation. A thermocouple on one side of the burner may not indicate excessive temperature, but, in fact, at a different radial position around the burner the recommended temperature is being exceeded. These thermal gradients produce high thermal stresses that cause severe warpage.

It was observed during the burner inspection that the burners located in the center of the windbox have experienced much higher temperatures than the outside burners. This has occurred when the burners are out-of-service and was caused by insufficient cooling air to the center burners. This phenomenon is illustrated in Figure 4, a typical printout of burner thermocouple temperature indications from Unit 1. Row H is out-of-service and burner number 3 is experiencing higher temperatures than the outer burners - which is generally the case. Also note that the secondary air damper is at 30% and not the usual 10%. The coal nozzle temperature variance is 70 to 100°F and the register plate variance is 100-140°F. These differentials will increase as the cooling air quantity is reduced. Indications are that the coal nozzle is approximately 280°F cooler when the burner is in service and the register plate is 200°F cooler. The temperatures on the throat seal fluctuate 300°F or more due to the large gaps in the slip seal casing. The thermocouple is evidently located near a large gap when a temperature of 600-800°F is reported. The air leakage through the large gaps in the slip seal casing only compounds the limited air flow problem. The air bypasses the burner and thus provides little cooling to the burner components. The air gap on the slip seal casing must be maintained at a minimum.
